Case History

FRAME ~ UP

The inspirational saga
of the resurrection
of a proud clapboard inn,
refurbished
for residential use.

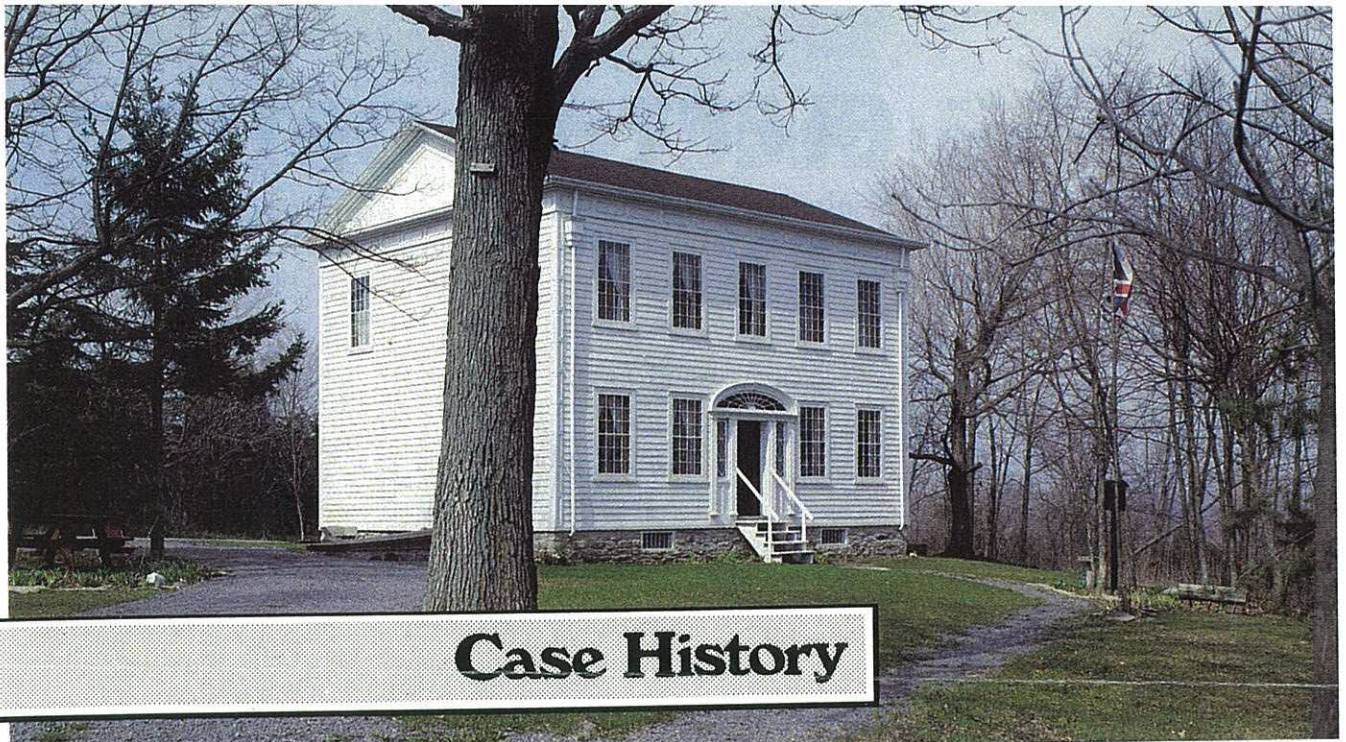
TOP: From ruin to renewal: today the old hotel proudly stands on a new site, its Greek-inspired dignity restored, painted white as Greek Revival structures often were.

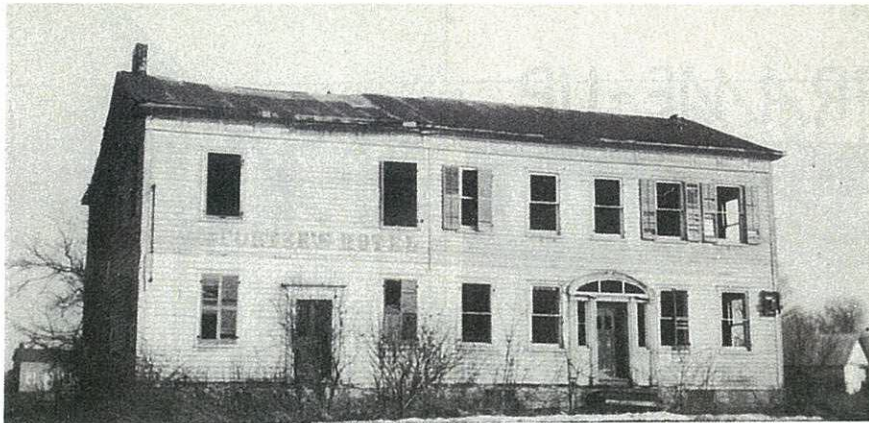
On its original site, 'Porter's Hotel' seemed a lost cause by 1965. Even so it was still an impressive building, worthy of recycling. Despite neglect, the original building (right) had weathered the years far better than the later addition (note serious sag in roof).

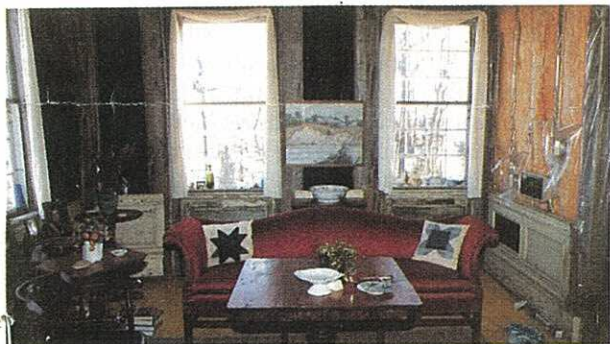
Treasures among tribulations: plastering and restoration of painted parlour panels are among the most pressing tasks still to be completed, yet the Stevens' traditional furnishings already look at home in their resurrected surroundings.

Although the family has moved into their renewed home, the project is far from complete; still at hand are a number of decorative tasks, not the least of which is the restoration of an extraordinary series of oil paintings found on the parlour panelling beneath several layers of overpainting. But why hurry? The house continues to be a labour of love for Marg and Roy and when finished, the restored former hotel will offer a warmly authentic atmosphere. The Stevens' story offers a remarkable inspiration that ably shows how a deserving old building can be given new life. Their example, assisted with a healthy dose of community spirit, displays the rewards of devotion and hard work. □

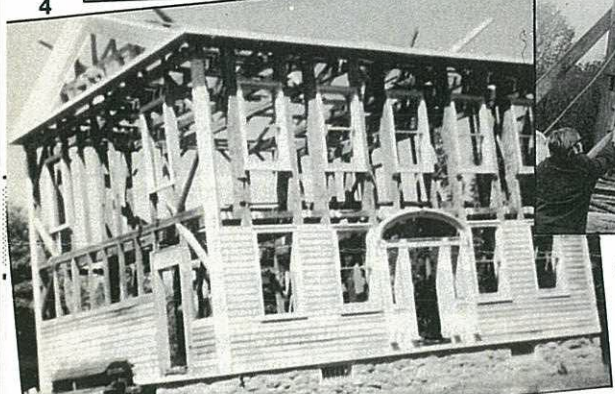
4

4. Taking shape: along the facade, you can count the 12 bents. With roof and window frames in place, the clapboard was then applied.

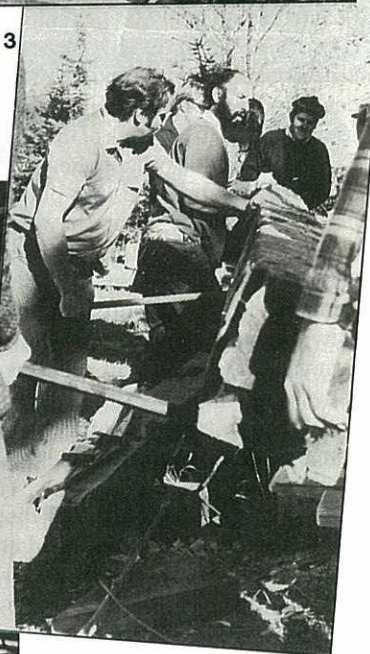
3

3. Men at work: neighbours and friends gathered for an old-style 'bee' to lend their collective muscle in raising the frame structure.

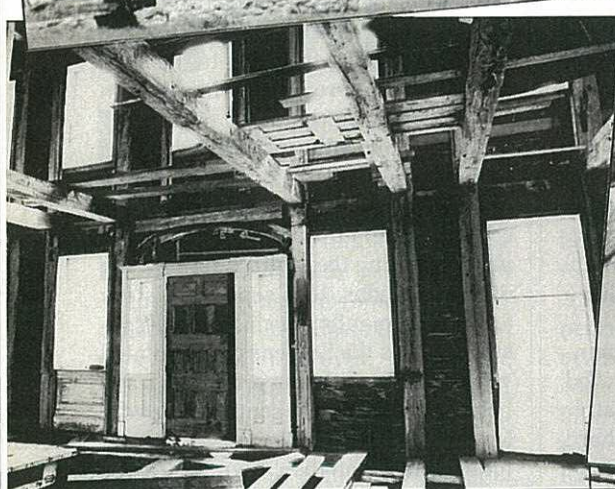
5. Viewing the interior as a shell offers an interesting lesson in 19th-century construction. The basic structure of the bents is quite evident.

Revealed for the first time was a fascinating historical aspect, as the hotel displayed a rare and early method of construction known as 'post-and-beam bent'. Framed like a barn, the hotel boasted twelve 'bents' (a typical barn might have four or five), each composed of an H-shaped arrangement of upright posts and horizontal beams which run from the front to the back of the building. Each member is a massive, hewn timber, mortised and tenoned into place with far more rigidity than the structure actually requires. This may explain why, despite years of neglect, the hotel had remained in good condition while later conventionally-framed additions had decayed beyond repair. It was this aspect that impressed Roy the most, and for him, reconstructing the hotel using the old bents was naturally a priority.
